BRITTLE FRACTURE AND STRUCTURAL FAILURE OF  
THE LIBERTY SHIPS DURING WW-II (A)

The spectacular failures of many welded ships during the early years of World War II created a major engineering emergency. The failures involved the loss of both ships and lives, at a cost to the nation of \$50 million. Approximately 5000 welded merchant ships were constructed; of these, over 1000 suffered cracks in varying degrees. Some 190 ships sustained serious fractures. A dozen broke completely in two.

## A. First View of the Problem

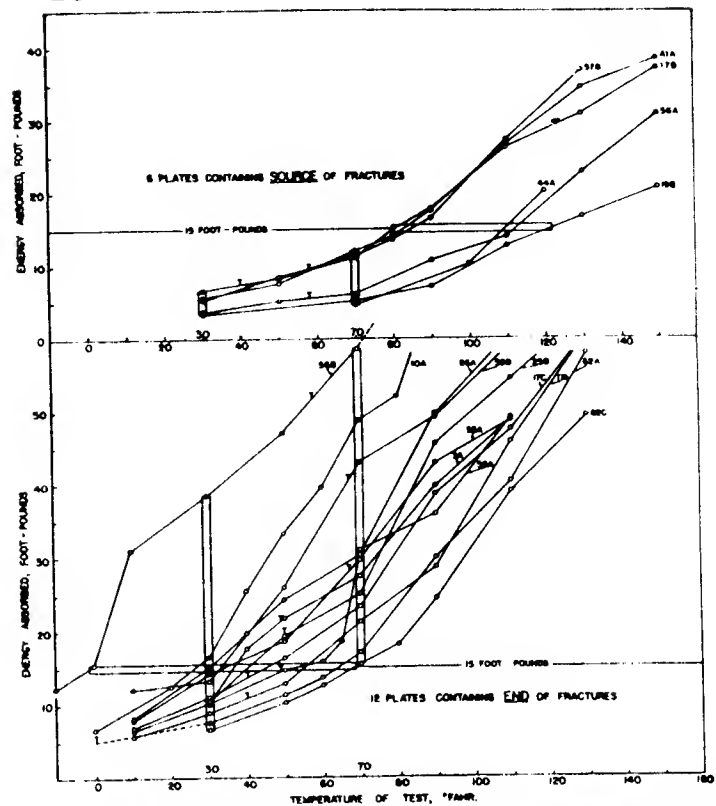
Fig. 27 Charpy V-notch test curves for some fractured ship plates 0.44-0.69 in. in thickness

Horizontal bars indicate range of 15 ft-lb transition temperatures for plates in which ship fractures originated (above) and plates in which fractures ended (below). Vertical bars indicate range of energy absorbed in tests at 30 and 70° F. Temperatures at the time of the ship failure are indicated by the letter T on the curves.

The upper part of Fig. 27 shows the Charpy V-notch test curves for some plates in which fractures in the ships originated, and the lower part shows curves for plates of corresponding thickness, in which fractures ended. The points representing the average values of energy absorbed in the multiple tests of each plate at each selected temperature are connected by straight lines, with no attempt to smooth the curves. The letter T on some of the curves indicates the temperature, if known, at the time of the ship failure. To compare the plates at the same energy levels, the temperature at which the curve crosses the line of 15 ft-lb energy absorption is taken as the 15 ft-lb transition temperature of the plate. The horizontal bars superimposed on each set of curves represent the range of 15 ft-lb transition temperatures of the plates in each category, and the vertical bars represent the range of average values of energy absorbed in tests at 30 and at 70° F.

It may be seen that the transition temperatures of the fracture source plates were higher, and the values of energy absorption at corresponding temperatures were lower than for the plates in the fracture-end category. In other words, the plates in which fractures originated were considerably more notch sensitive than the plates in which the fractures ended.

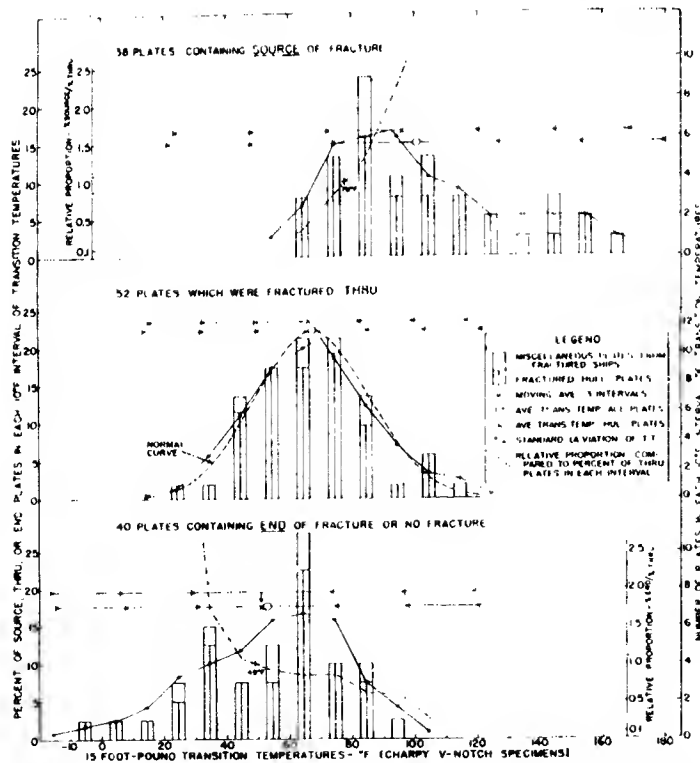
Fig. 30 Frequency distributions of 15 ft-lb transition temperatures of plates in the fracture-source, fracture-through and fracture-end categories

The distribution of the fracture-through plates (center) approximates the normal curve. The fracture source plates (top) have a higher average transition temperature, and the relative proportion of fracture-source to fracture-through plates in each interval (dash-dot line) increases with increasing transition temperature.

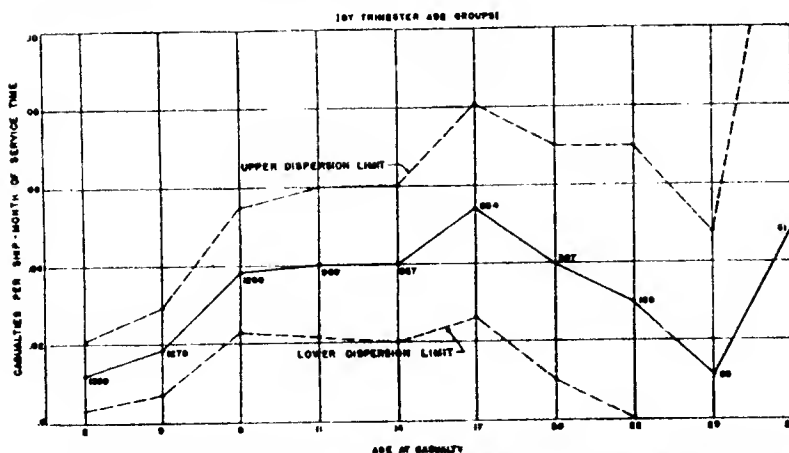
Fig. 14—Casualties per 3-Mo. Period (Winter 1943-44) Divided by Ship-Months' Service in Same Period; Merchant Vessels Built by Maritime Commission (See Table 1)

The date and age data permit study in many different ways. A sample plotting of winter casualties, Fig. 14, shows that casualty rate is not appreciably affected by age.

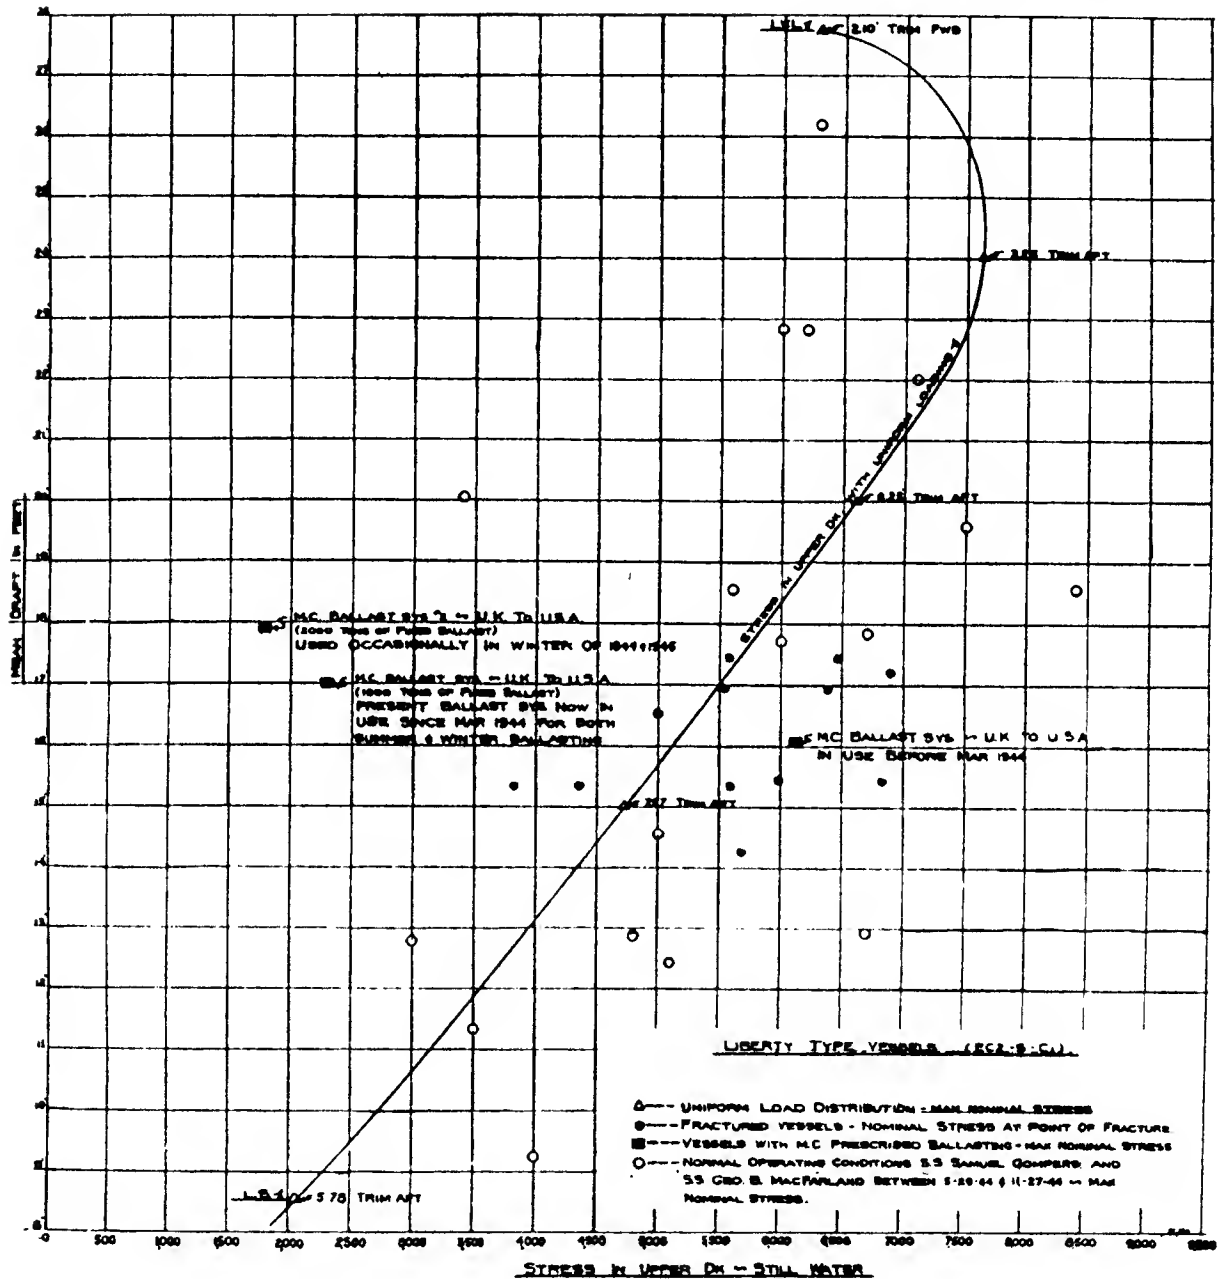
In order to obtain a base line to which comparisons could be made, calculations were made on the Liberty ships at several different drafts with a loading which was uniformly distributed so that the trim was representative of typical operating conditions. Typical trim conditions at various drafts were obtained by recording the fore and aft drafts of 216 ships from the log books. The trim used in the calculation was the average of the scattered plots. From these bending moment calculations, the maximum tensile stress in the crown of the deck amidships was determined and is indicated in Fig. 16 by triangles and a solid line. The maximum nominal stress value in the deck with this type of loading was about 7600 psi tension at 24 ft. mean draft. Comparison between the uniform loading used for this calculation and the numerous loading charts forwarded to Coast Guard Headquarters indicates that the uniform loading was practically typical and can be considered so.

For further comparison, stresses from bending moment calculations performed by the University of California on two Liberties have been plotted as hollow circles. It will be noted that the scatter of points follows the general trend of the line of uniform load distributions. In addition, a calculation was made on a condition representative of the most severe

Finally, calculations were made on several vessels which had cracked. The nominal stress at the point of fracture is plotted with solid circles. The scatter again centers around the line of uniform loading. This indicates that the loading on the vessels which fractured was apparently not abnormal even though the stress from loading is appreciable.

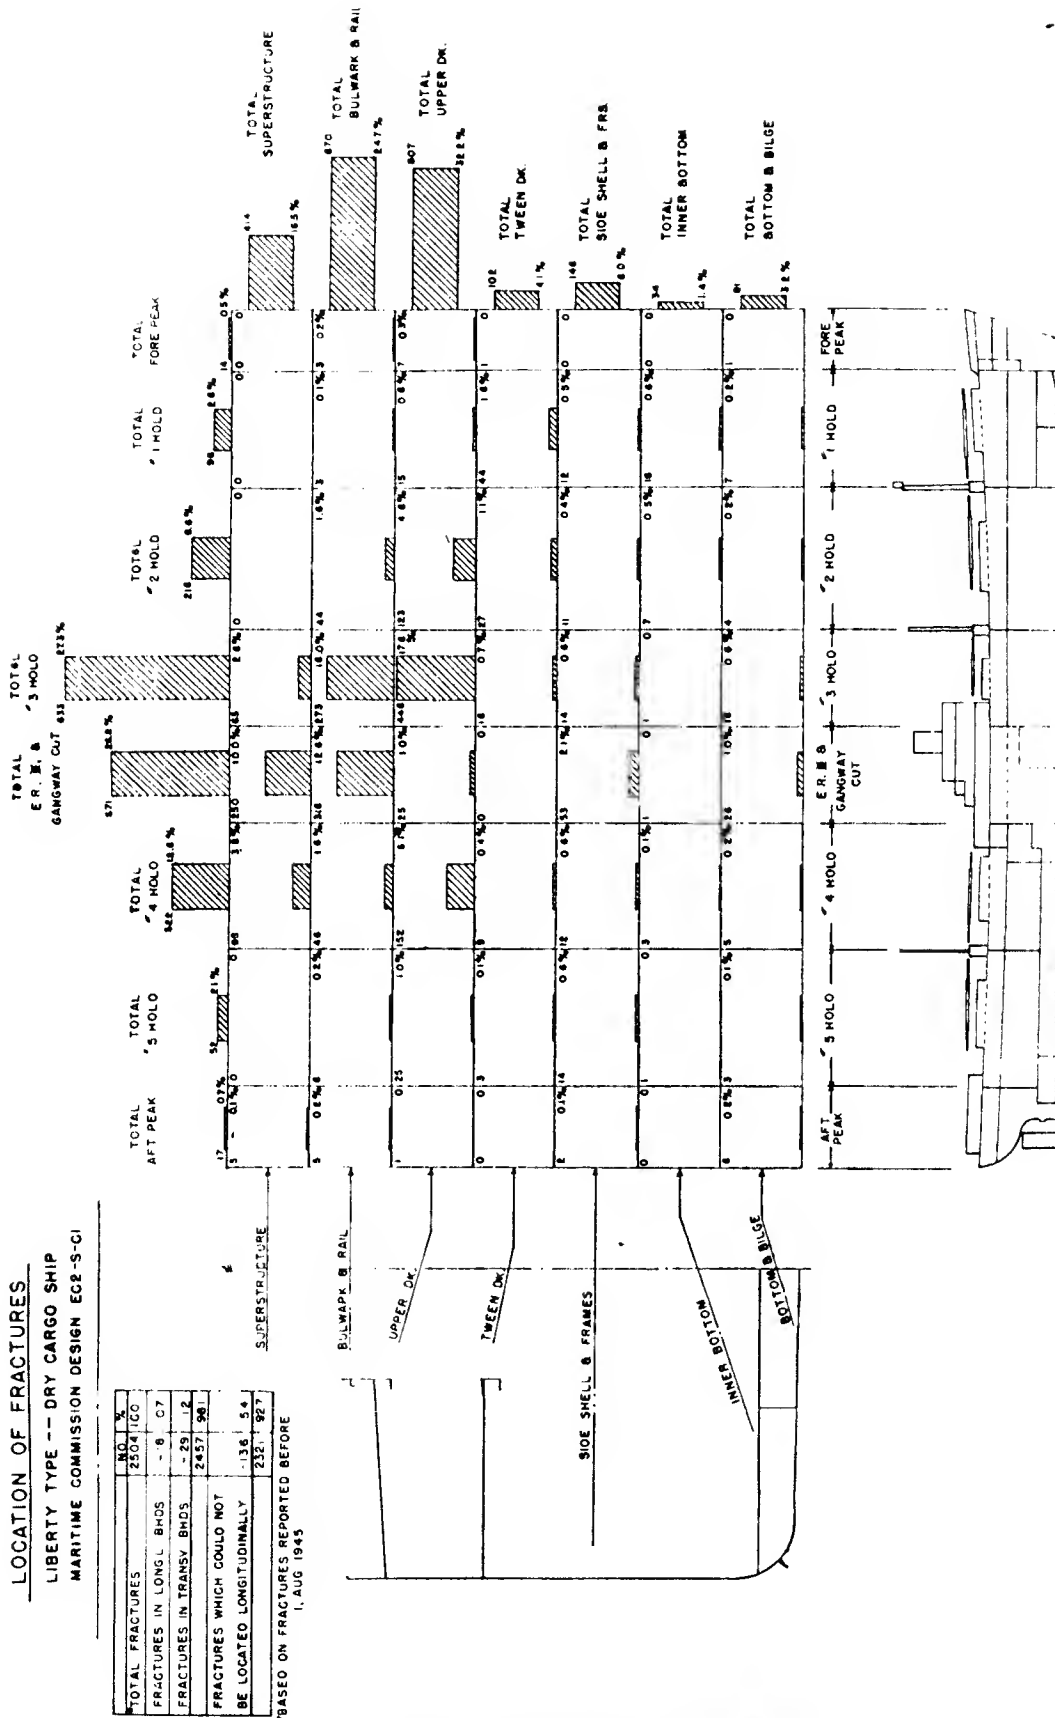
Fig. 17

A plot, Fig. 17, has been prepared showing the longitudinal and vertical location of all classes of fractures on the Liberty

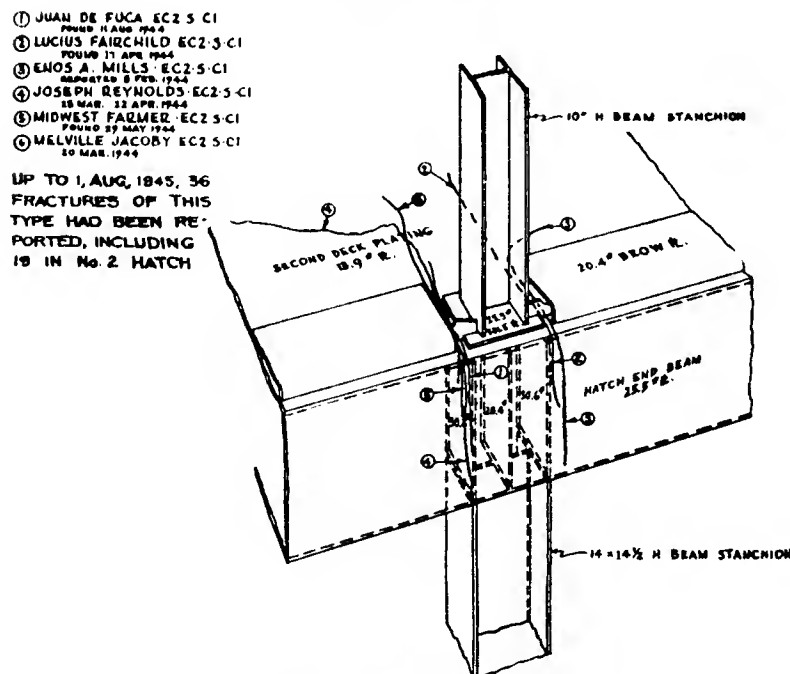
It has been noted that the fractures at the center-line stanchion of the second deck almost always occurred as a result of rough weather. The second deck at the edge of the hatch is under high tension whenever there is cargo loaded in the tween decks because the heavy supporting H stanchion is just beneath. Most of these fractures have occurred in the forward end of No. 2 hold and the aft end of No. 1 hold. This is just about where maximum pounding would be expected. The thrust of the bottom force overcoming the inertia of the tween deck cargo produces high stresses in the deck over the H column. In addition, notches around the sole plate of the tween deck stanchion and the ends of brow plates magnify the stress, Fig. 23.

Fig. 23—Liberty Vessel; Centerline Stanchion, Second Deck

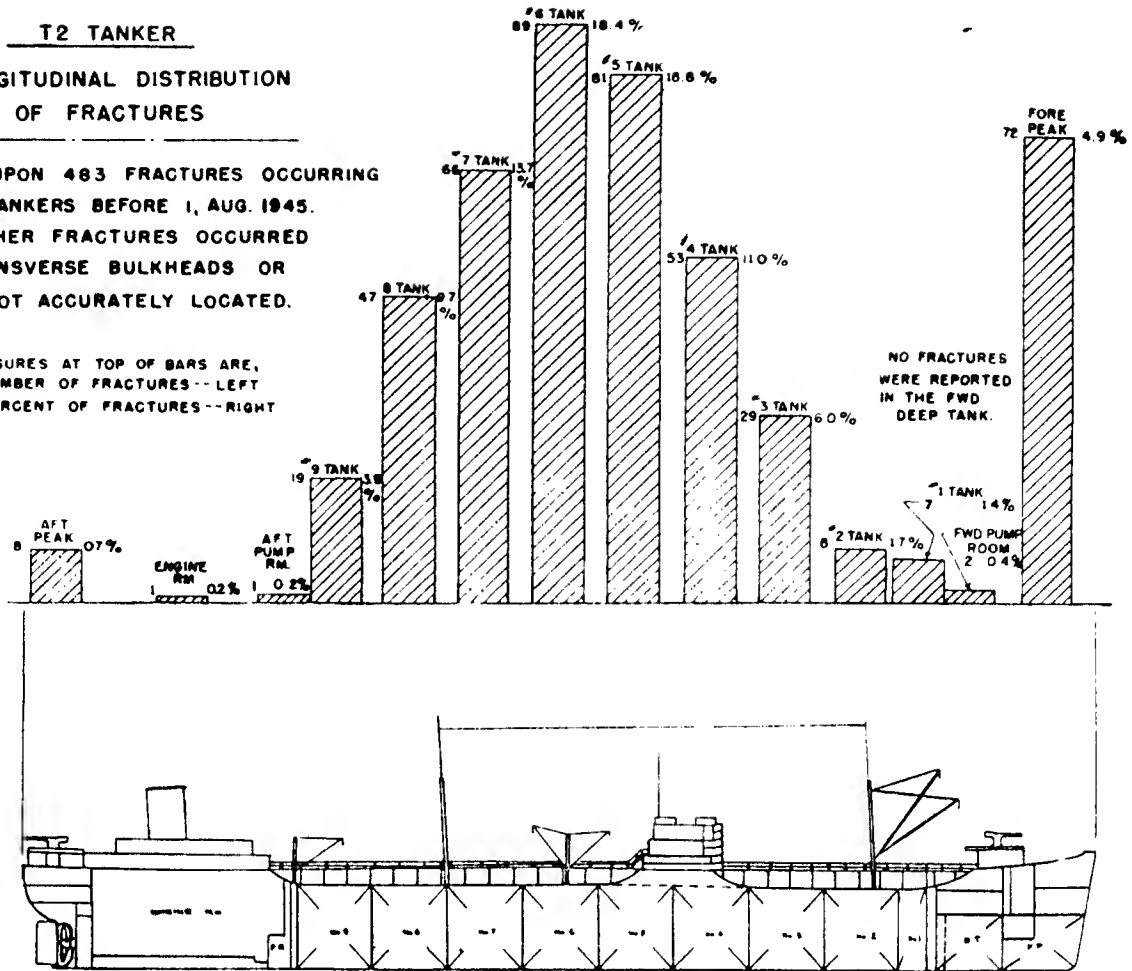
The longitudinal distribution of the fractures on the T2 Tankers also shows a peak amidships indicating that bending of the hull is partly responsible for their occurrence, Fig. 24. All of the nine serious casualties occurred in Nos. 3, 4, 5, 6 and 7 tanks.

The large number of fractures in the forepeak indicated in Fig. 24 have involved many details of the internal structure. They are local in nature.

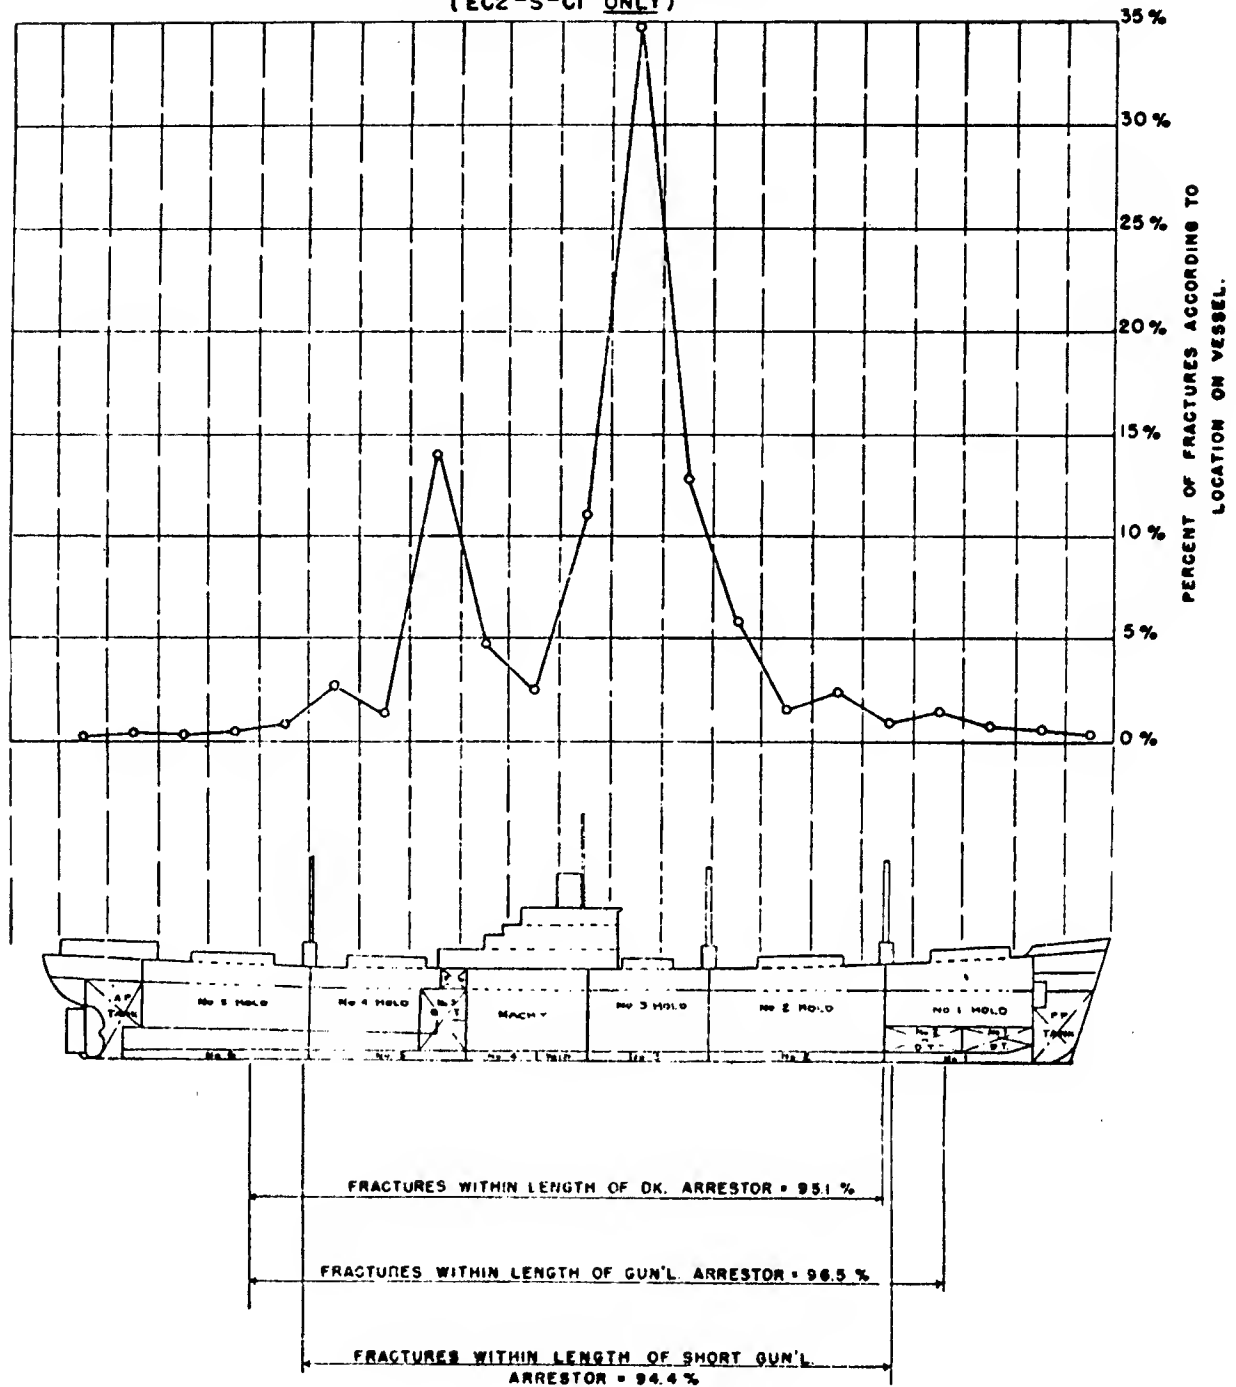
Fig. 36

Figure 36 was originally prepared to weigh the effects of reducing the length of the gunwale crack arrestor and shows the per cent of the fractures in way of arrestors of various lengths.

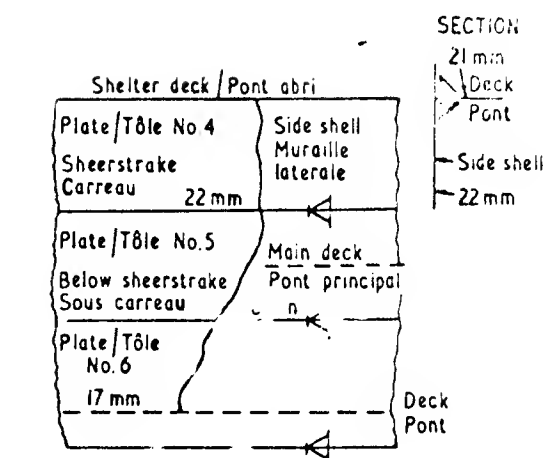
PATH OF THE CRACK (LOOKING PORT)  
TRAJET DE LA CASSURE (VU DE L'AXE VERS BD)

Two fillet welds, joining coaming and deck plating were concerned. They had been inspected visually.
